**Waters Delineation Report  
2843 Mount Pleasant Rd  
Mt Joy, Pennsylvania**

**November 2025**

Northland Airboats Marine & Environment, Inc.

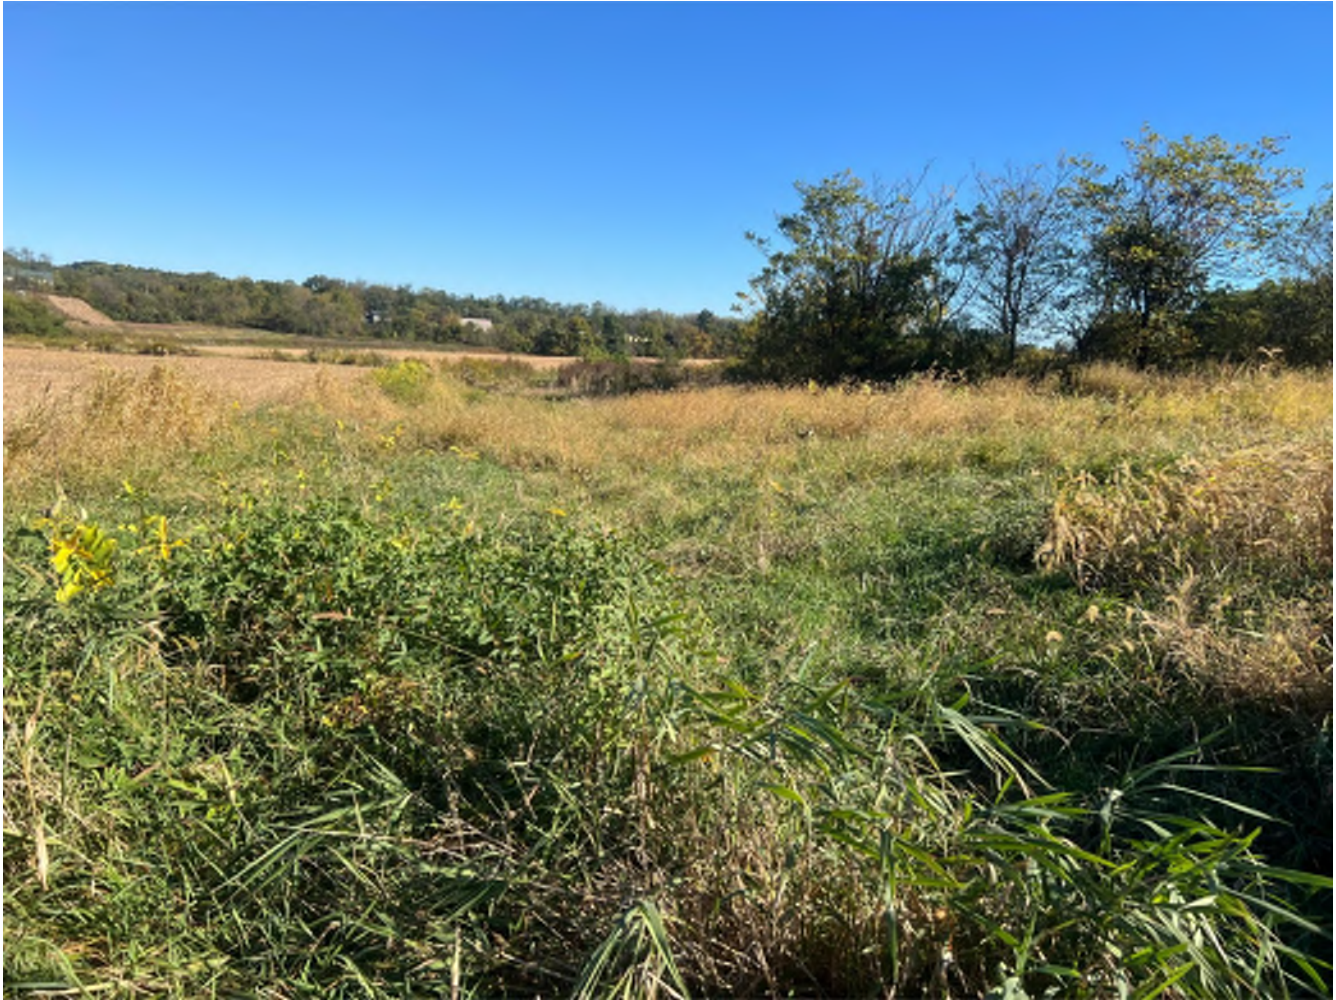
**Photograph 1:** Swale from Mt. Pleasant Road to farm pond. This image is looking northeast along the swale.

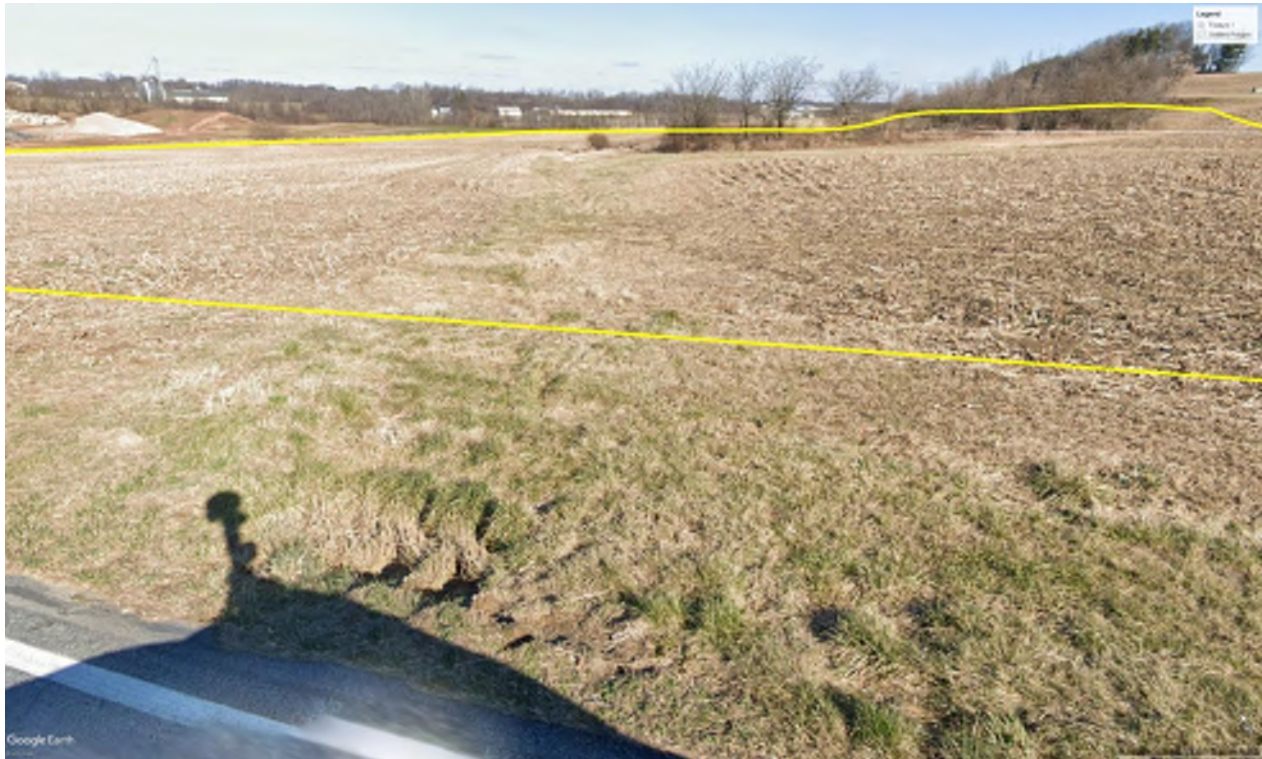
**Photograph 2:** Google Earth wintertime image of the same swale, from the same vantage point, as shown in Photo 1.

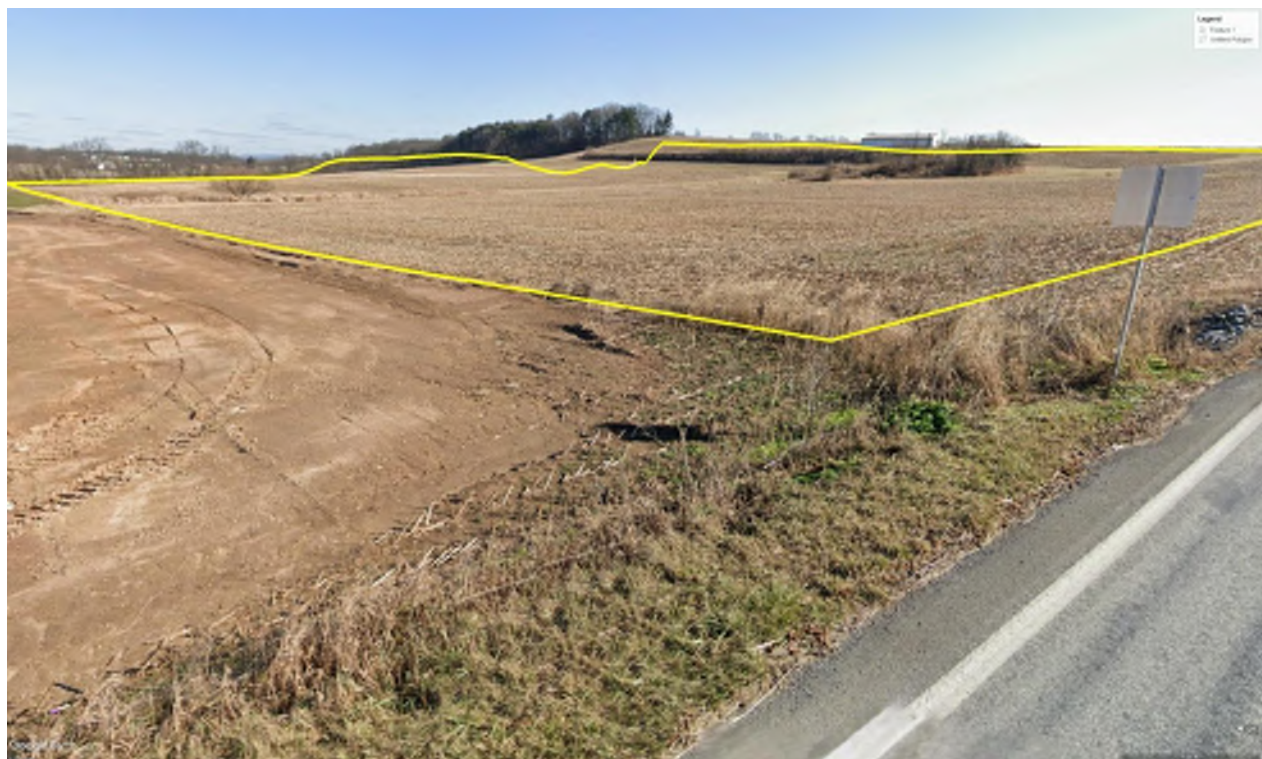
**Photograph 3:** Google Earth wintertime image of the westernmost property corner showing swale (looking eastward)

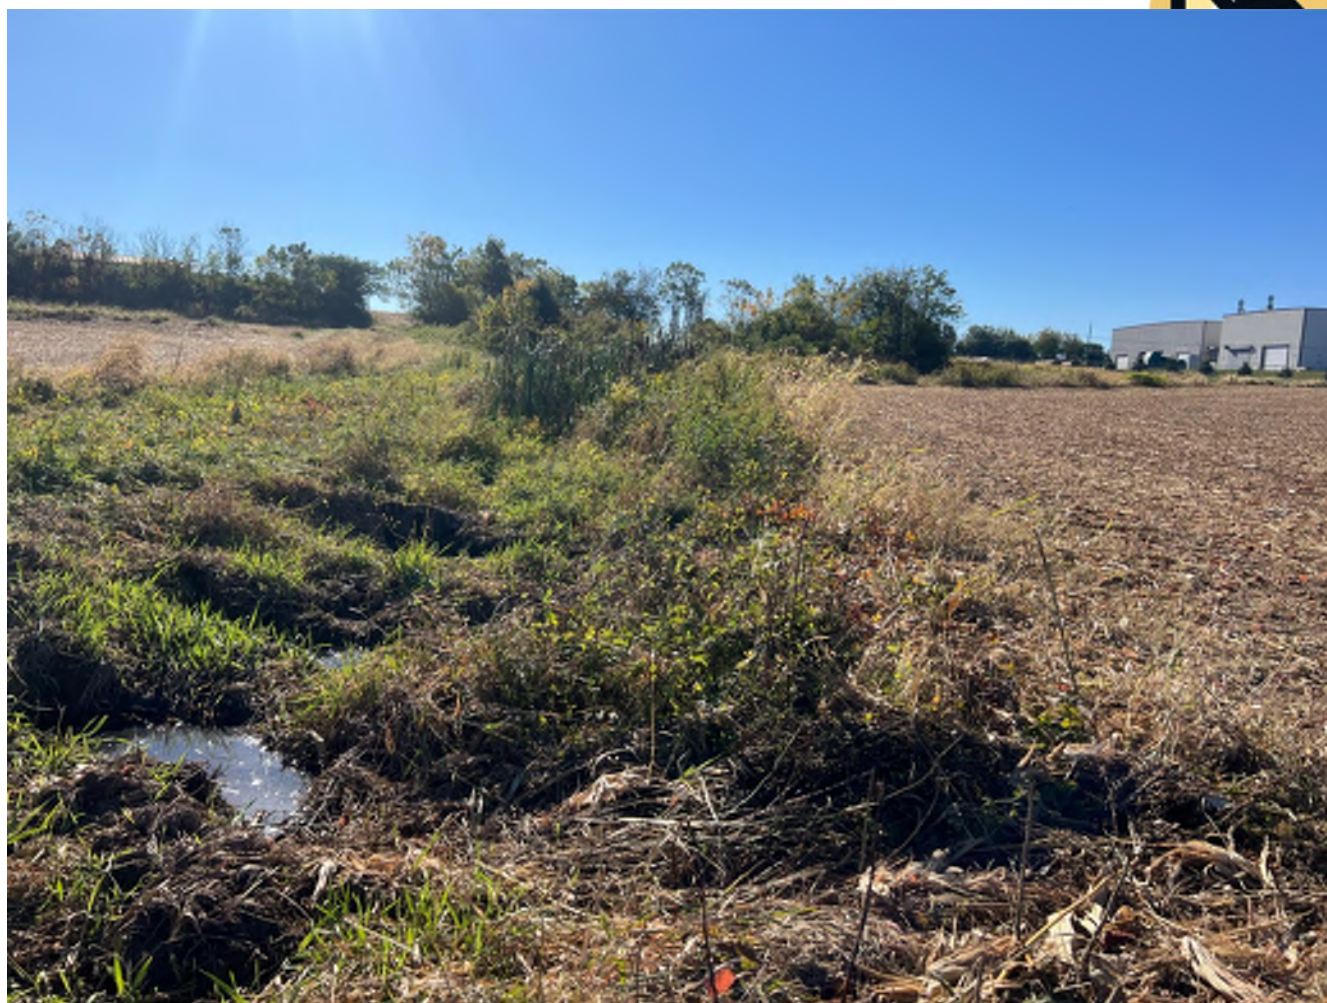
**Photograph 4:** Swale below old farm pond. The pond is within the trees near the top center of the image and the flow is northward out of the pond toward the image location. Farm equipment wheel ruts (some with water) are visible crossing the swale in the foreground. Image looking southward.

Outside the berm to the north, the flow continues northward for approximately 300 feet along the PEM vegetated wetland swale. The swale exhibits wetland diagnostic vegetation, soils, and hydrology where delineated. At the approximate northern terminus of the delineated wetland, the wetland is cut off by a farm road crossing, that is repeatedly crossed by farm vehicles. Wheel ruts are visible at the crossing. Within the crossing and north of the crossing, wetland hydrology, wetland soils and wetland vegetation are not observed.

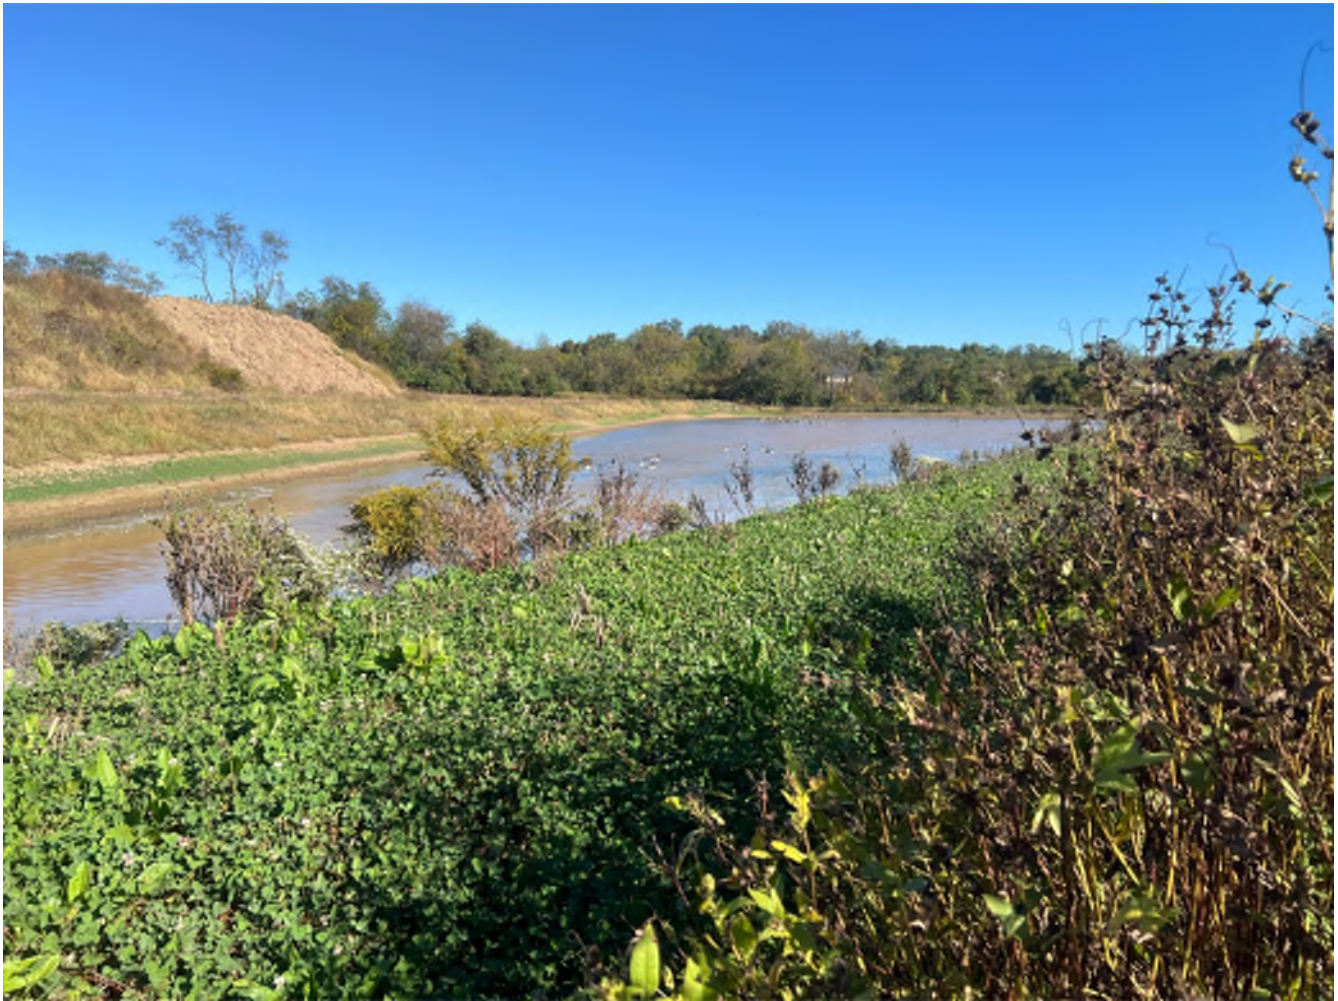
**Photograph 5:** Offsite stormwater basin to the north of the Site. At the time of the field investigation, the water in the basin was approximately 4 – 5 feet below the ground elevation on the site, suggesting groundwater is well below the rooting zone.

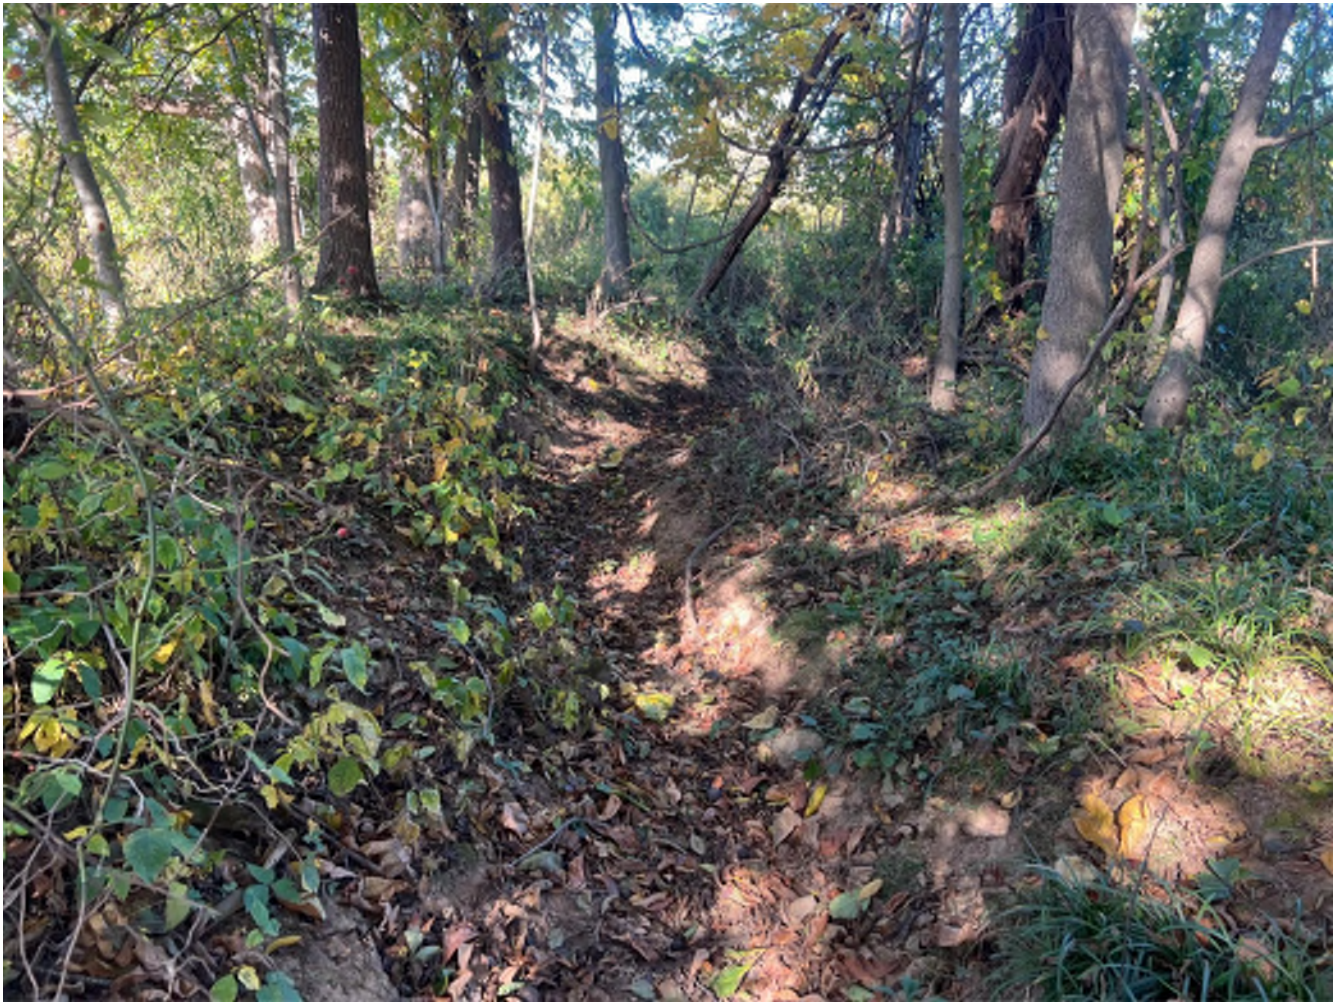
Photograph 6: Upper onsite terminus of intermittent stream looking approximately northeastward

One (1) watercourse was identified on-site, it begins at the terminus of an upland swale, then extends eastward through forested land between agricultural fields for approximately 900 feet. This portion of the watercourse is straight as if dug by machine, although it is mapped as an intermittent stream. Once entering the mature forest onsite, the watercourse continues eastward through a narrow valley between two relatively high and steep slopes before continuing eastward offsite.

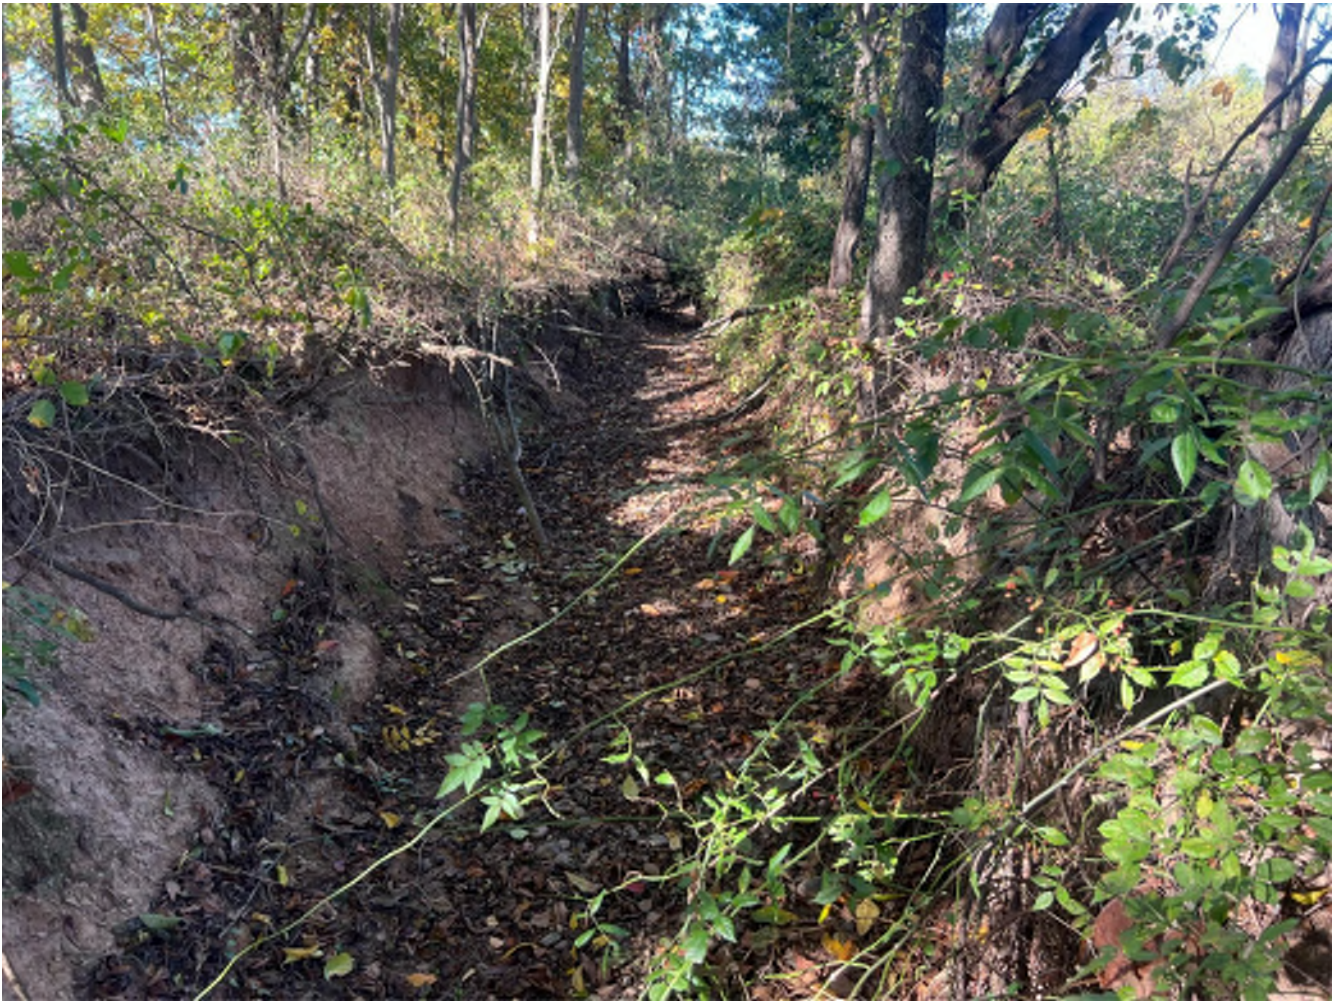
Photograph 7: Intermittent watercourse channel along northern parcel boundary looking approximately northeast. The watercourse was dry at the time of this photo.

The onsite portion of the watercourse was flagged where there was a defined channel comprising bed and bank. During the October 2025 field effort, the entire length of the stream was dry (except for two small puddles at local low spots). Apart from the dry nature of the stream, observations that point to intermittent flow include the absence of onsite point bars, debris jams, sediment sorting, or defined thalweg.

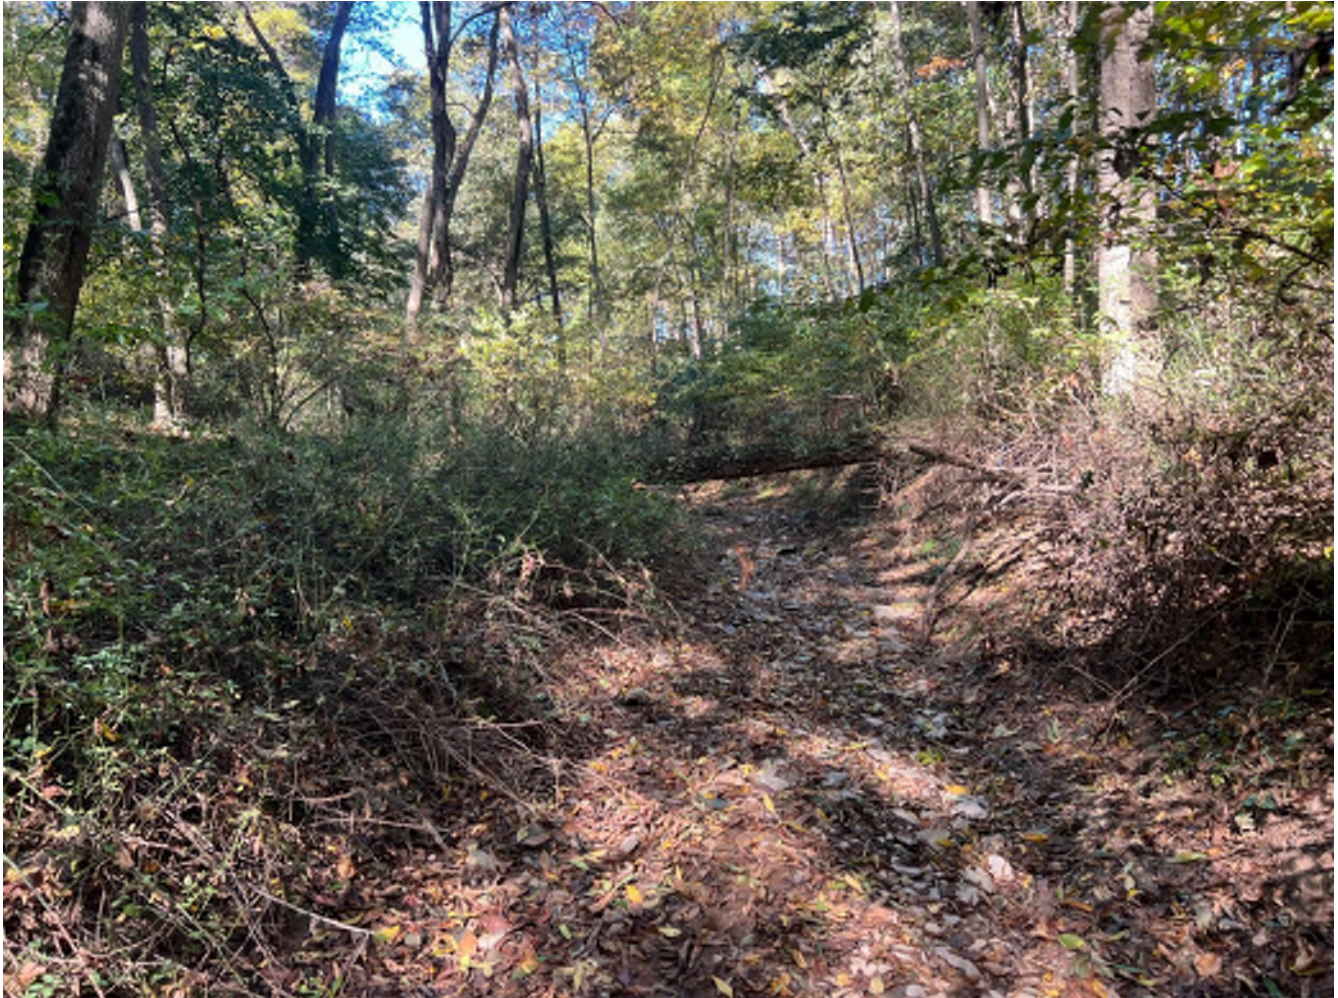
Photograph 8: Typical intermittent watercourse cross section looking upstream (northwest).

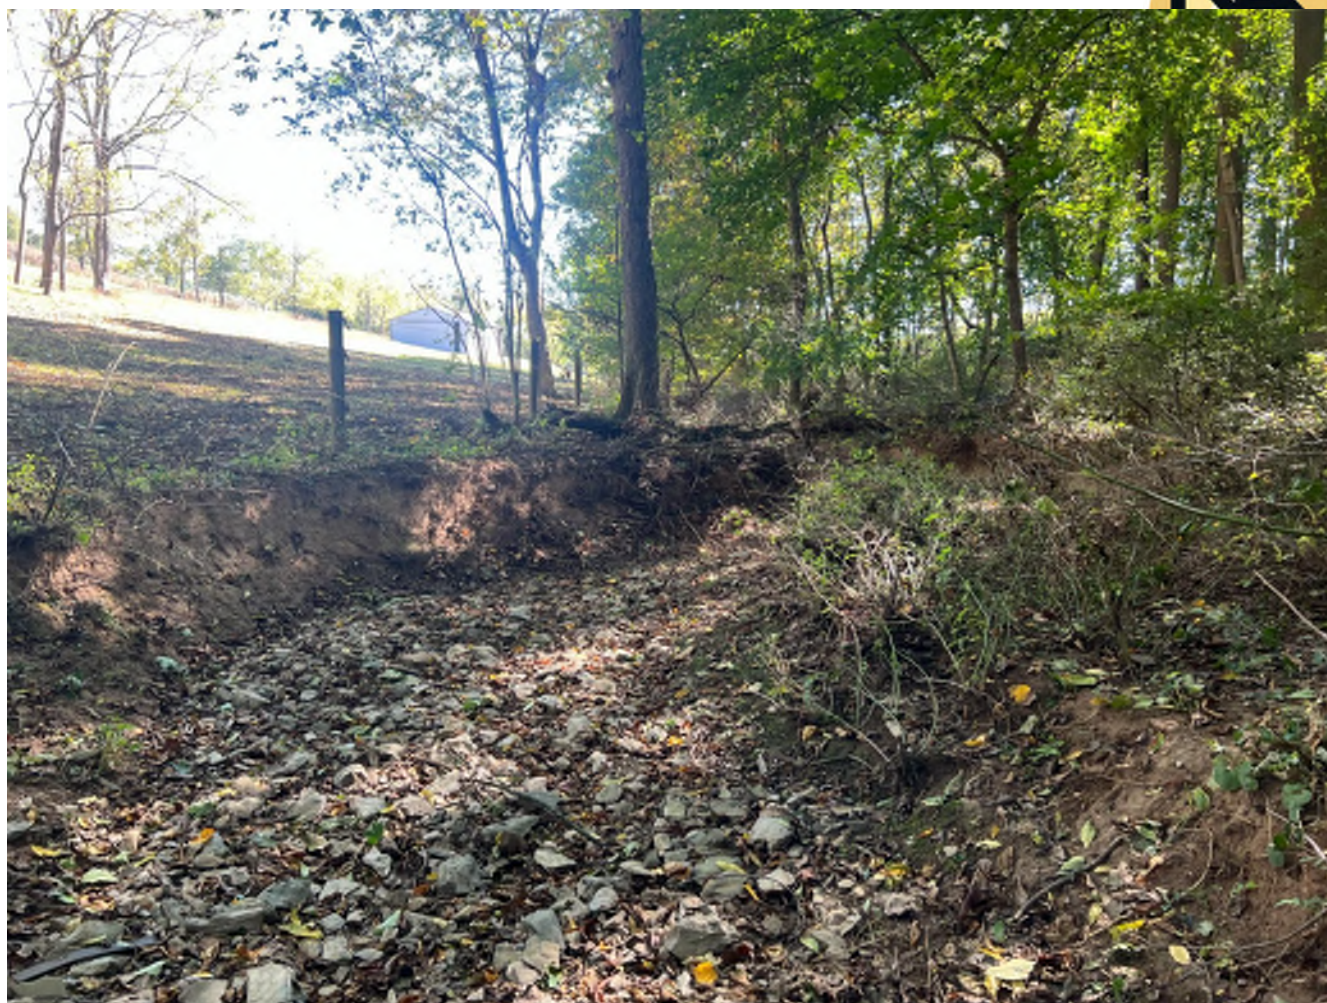
Photograph 9: The eastern end of the onsite watercourse reach looking northeast. The outbuildings in the image are offsite to the northeast,

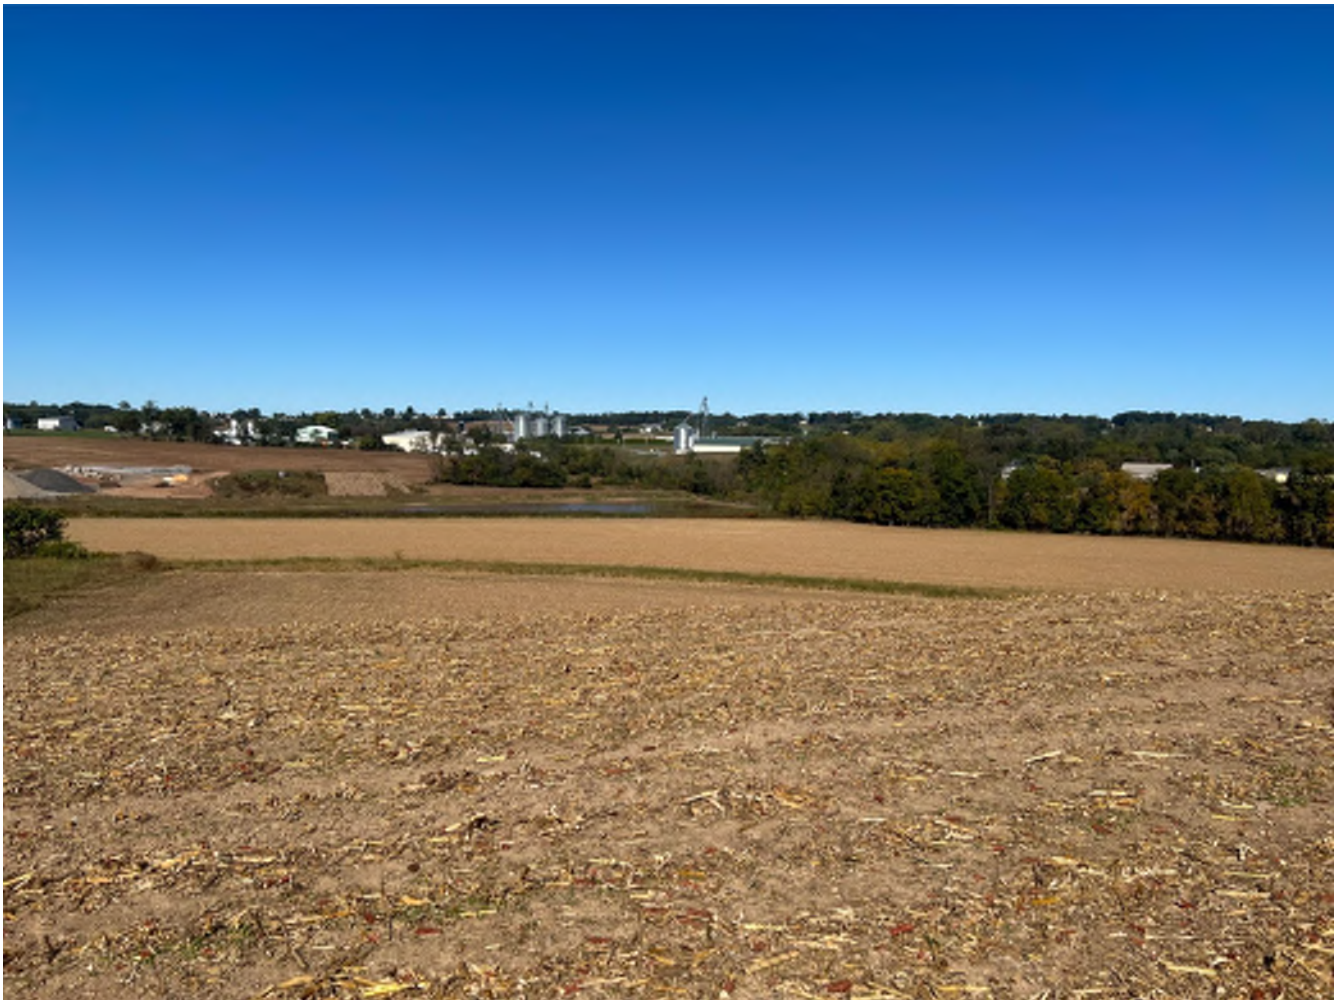
**Photograph 10:** Image looking northward from onsite high point. The offsite detention basin is visible in the distance.

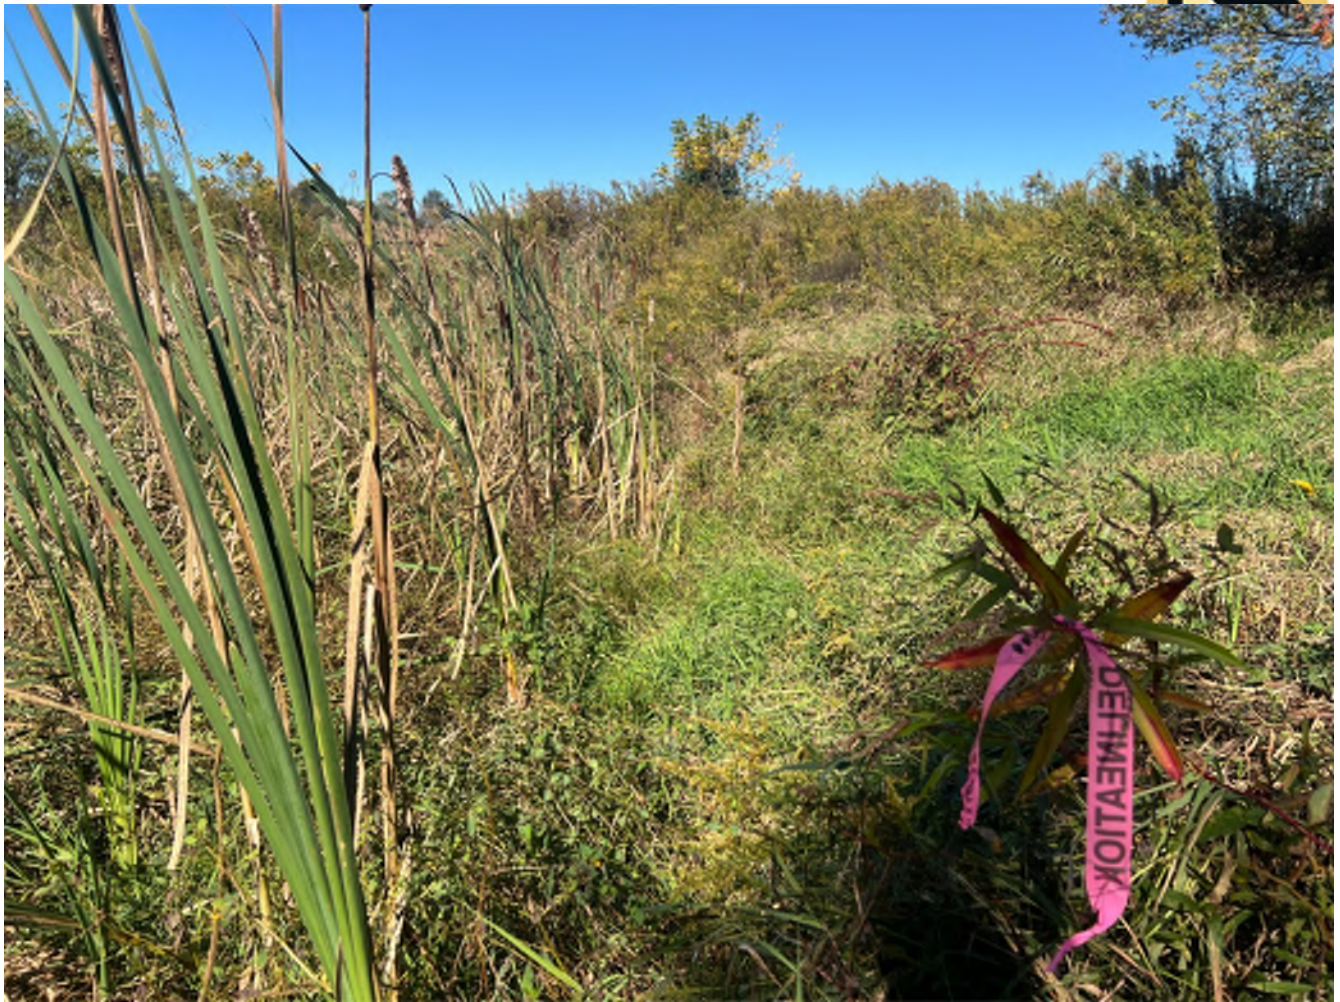
**Photograph 11:** Emergent wetland within the old farm pond berm. The berm is to the right in this image. Image looking north.

The single onsite delineated wetland (12,336 square feet) appears to have been associated with a former farm pond. The foundations of what appears to be an old springhouse were found near Wetland Flag 3, and surface water was expressing from the ground within the foundation. Water from the spring is largely contained by a manmade berm that is roughly teardrop shaped. The berm appears to have failed relatively recently between Wetland Flags 7 and 12, because fresh earth is apparent at this location and the berm can be seen in cross section where the flow leaves the impoundment through this breach.

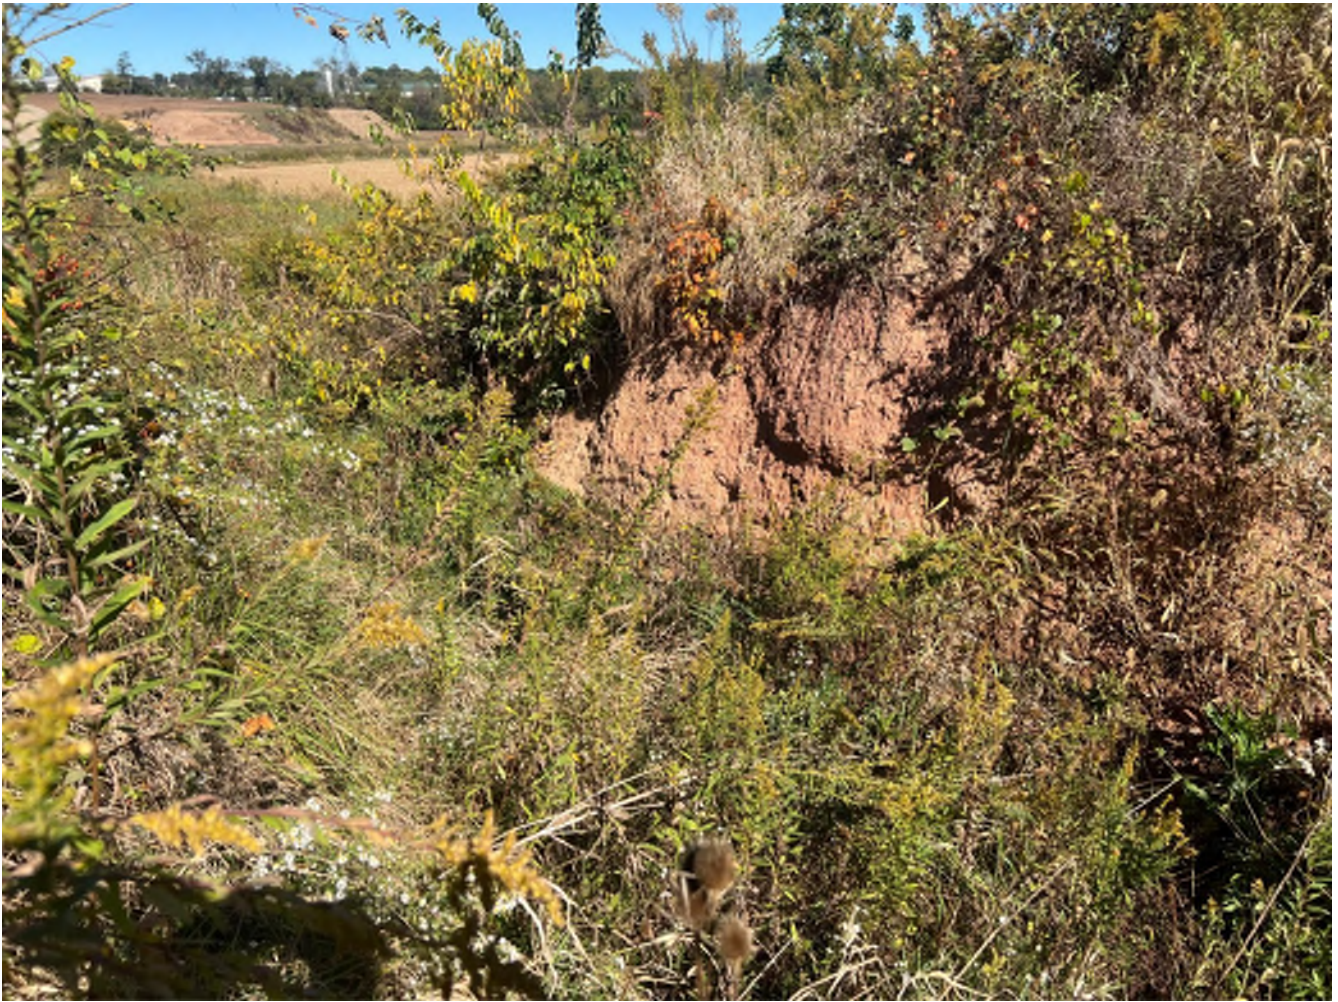
**Photograph 12:** Breached farm pond berm between wetland points 7 and 13. Photo looking north

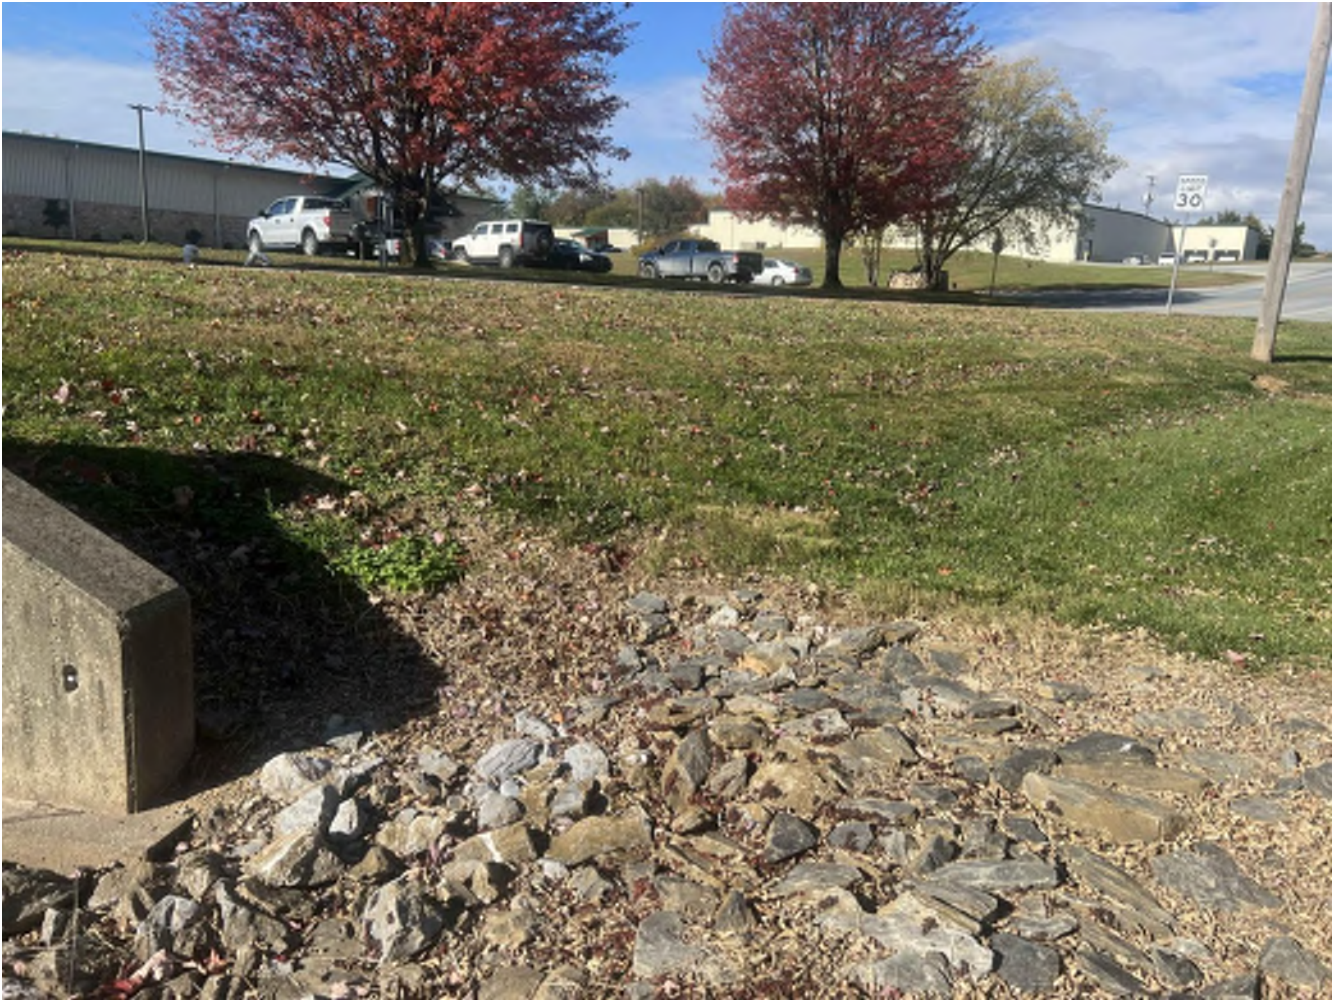
Photograph 13: Culvert at rip-rap apron at the low point of the paper street location on Steel Way Drive (road in background).

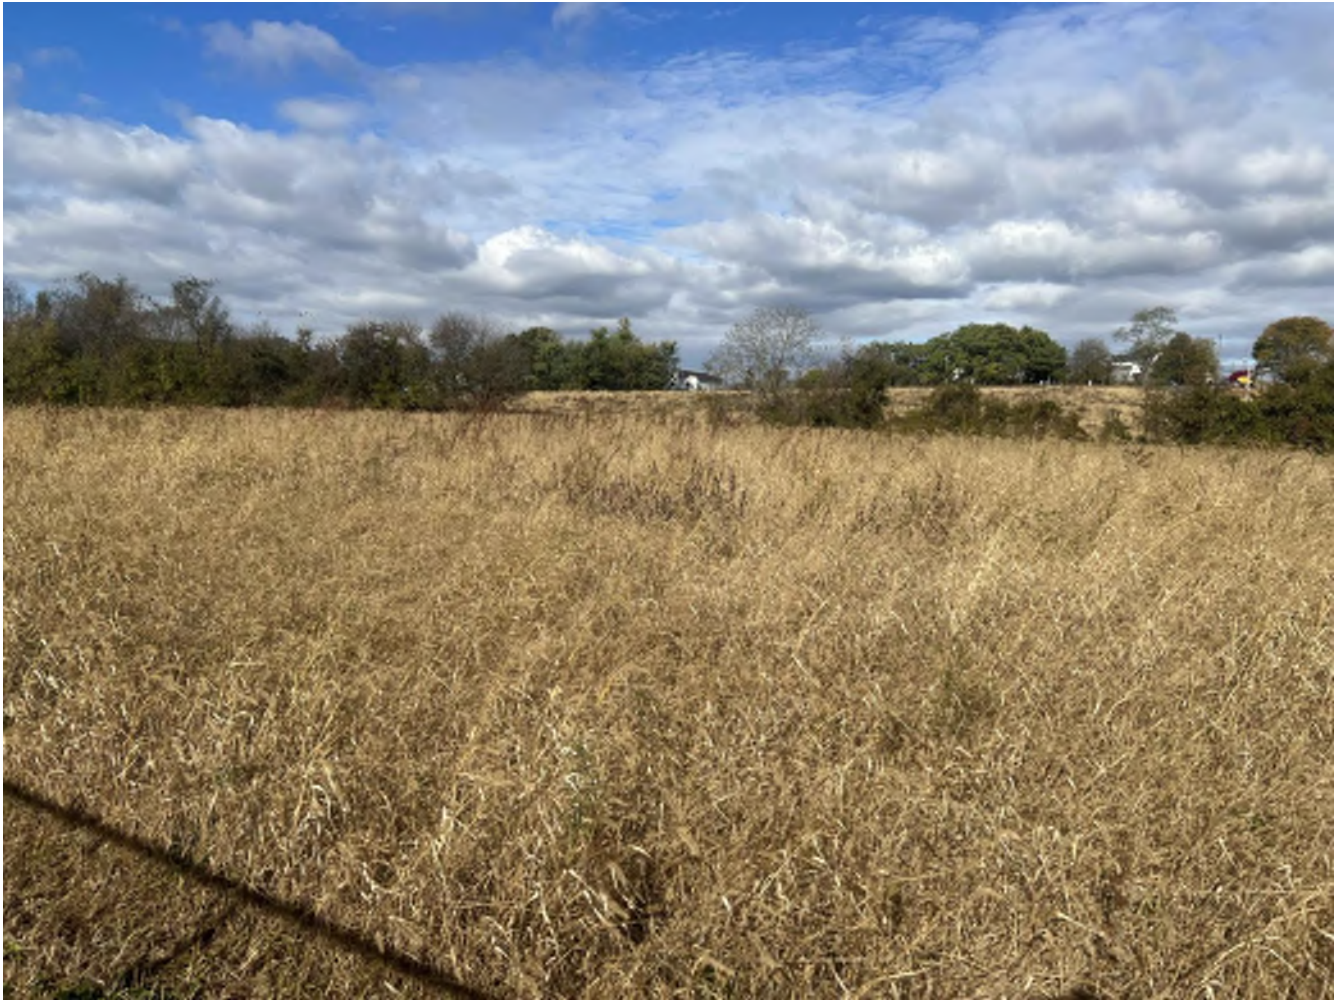
**Photograph 14:** Abandoned agricultural field in the location of the paper street between Steel Way Drive and Mount Pleasant Road.
