**Environmental Impact Statement**

**SUNN 1020, LLC**

MOUNT JOY TOWNSHIP  
LANCASTER COUNTY, PENNSYLVANIA  
SEPTEMBER 2026

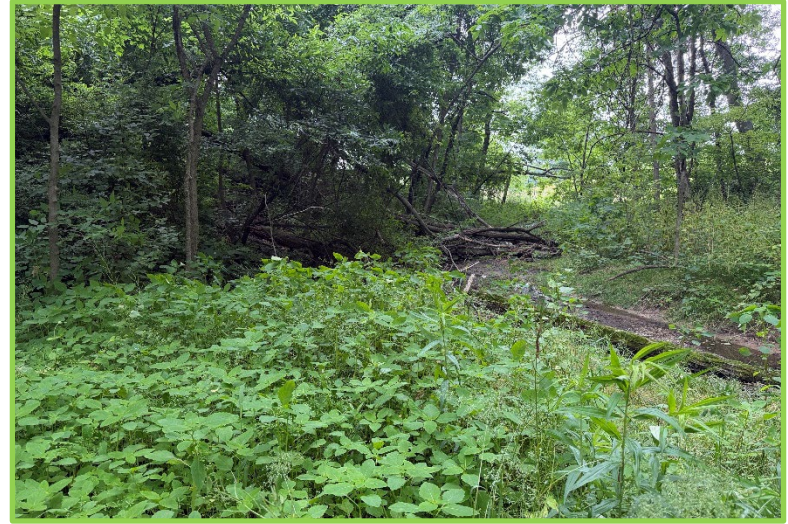
PEM Wetland 1

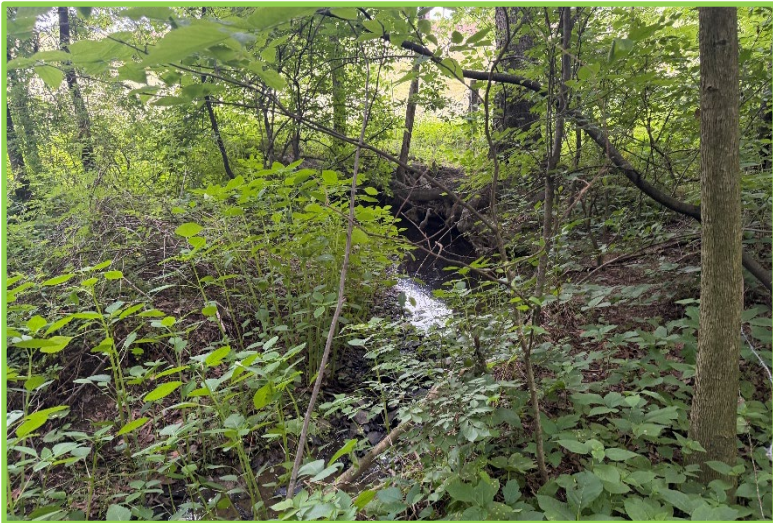
Intermittent Stream 1

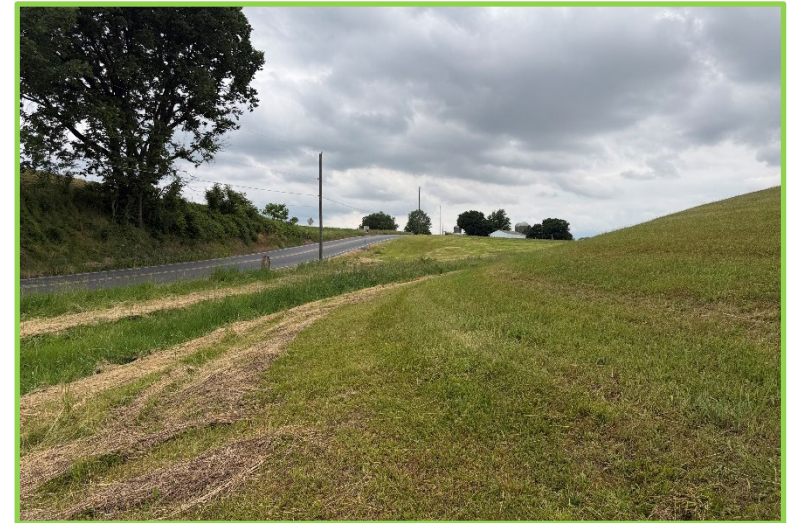
Ephemeral ditch

Ditch 1 is an ephemeral ditch that flows north and joins Stream 1 and then continues outside the eastern boundary of the Study Area. The ditch originates from a drain tile in the eastern part of the Study Area. The ditch is approximately 600 linear feet and has a substrate of silt and organic materials. No flow was noted from the drain tile at the time of the delineation field work. The ditch appears to have been constructed to facilitate drainage of the surrounding agricultural fields.

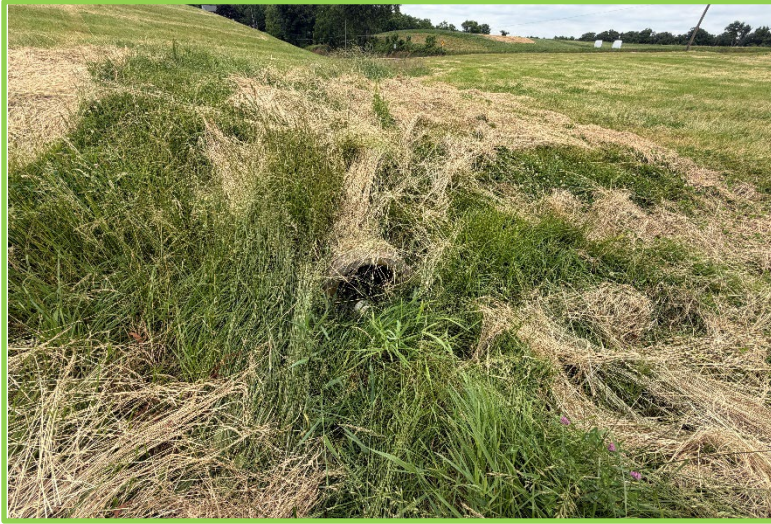
Drainage tile and culvert in ephemeral ditch

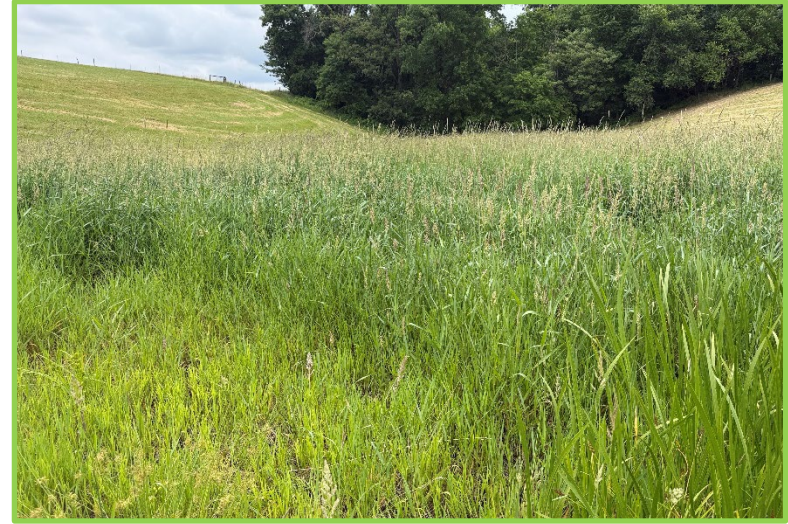
PEM Wetland 2

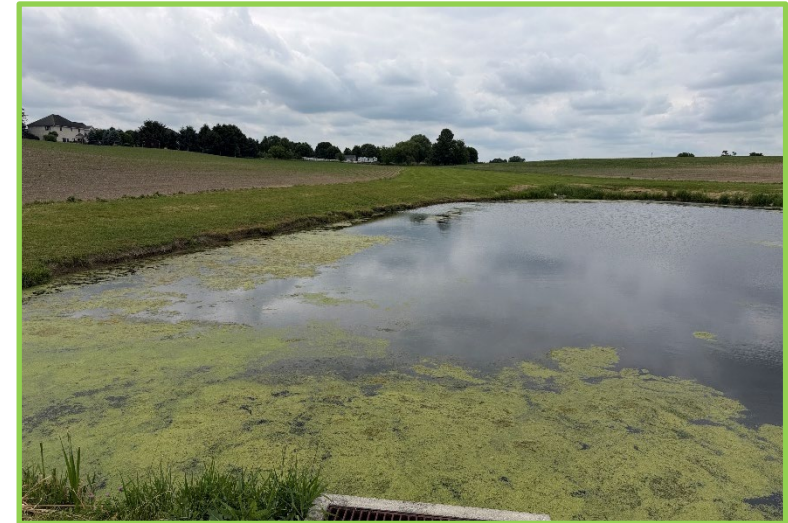
Pond (PuB)
