**Re: Third Quarter 2023 Environmental Monitoring Report
WM Lancaster Landfill, Facility ID# 101559
Mount Joy Township, Lancaster County, Pennsylvania**

**LANCASTER LANDFILL
MOUNT JOY TOWNSHIP, LANCASTER COUNTY, PENNSYLVANIA
PADEP I.D. NO. 101559**

**THIRD QUARTER 2023
ENVIRONMENTAL MONITORING REPORT**

**Prepared by:
Civil & Environmental Consultants, Inc.
4350 Northern Pike, Suite 141
Monroeville, Pennsylvania 15146
CEC Project 306-896**

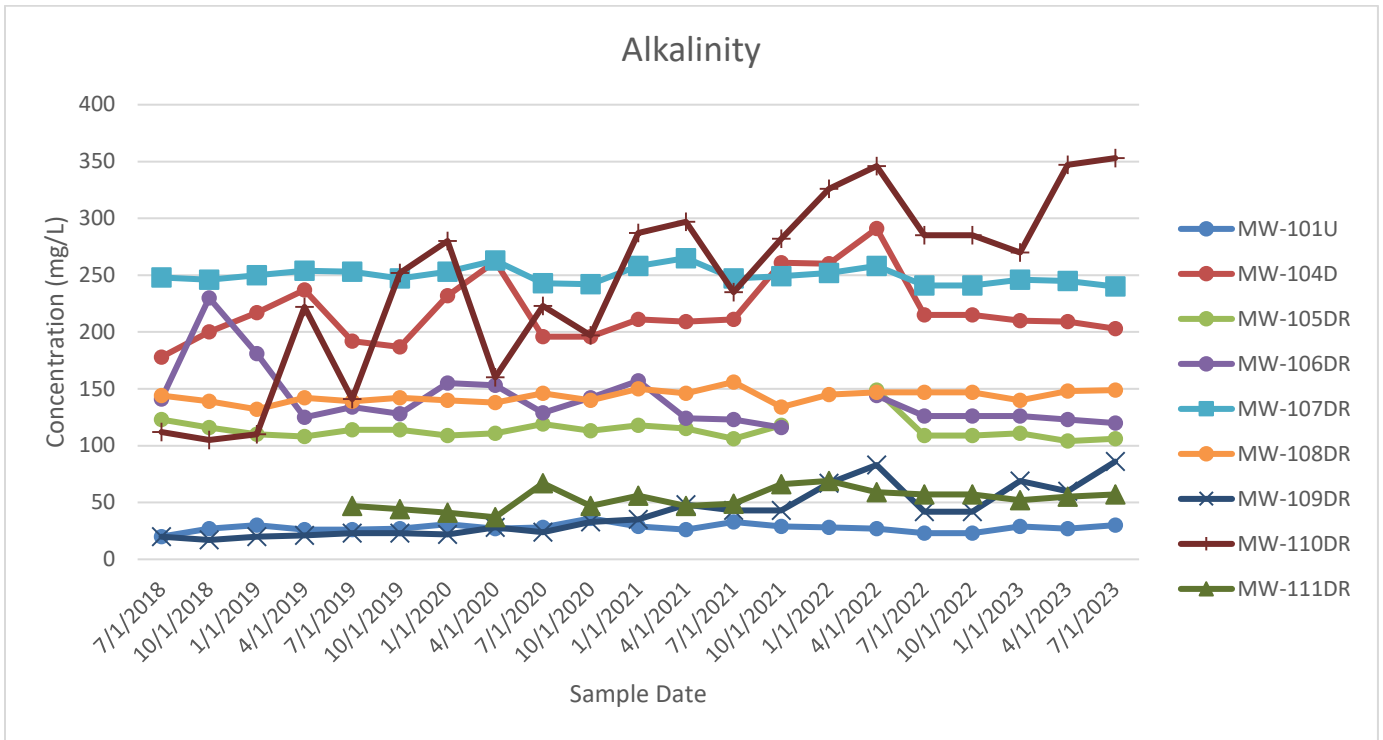
FIGURE 4

As shown in the time-series graphs for the monitoring wells installed in the New Oxford Formation Hydrostratigraphic Unit (Figure 4), no historically significant upward trends were observed, except for alkalinity at MW-109DR and MW-110DR and TDS at MW-110DR. These trends do not appear to be a result of leachate influence because the remaining indicator parameters are relatively stable over the same period of time. It should also be noted that chloride, sodium, and TDS in MW-106DR and MW-107DR appear to fluctuate seasonally; however, detected concentrations are within historic levels.

NEW OXFORD FORMATION
TIME SERIES PLOTS

Note: MW-105DR and MW-106DR were first sampled 1st Quarter 2022; prior results shown are from MW-105D and MW-106D.

- Time-series analysis of select groundwater leachate indicator parameters shows no significant upward trends in these constituents through time, except for alkalinity at MW-109DR and MW-110DR and TDS at MW-110DR. However, these trends do not appear to be a result of leachate influence because the remaining indicator parameters are relatively stable over the same period of time.
